CAUSE ANALYSIS OF SNOWMELT-INDUCED EXPRESSWAY SLOPE FAILURE THROUGH LABORATORY TESTING

Kazuhiro Tsuchiya

Maintenance Department, Hokkaido Branch,
Japan Highway Public Corporation
Tél.: +81-11-896-5211 / Fax: +81-11-896-5888
E-mail: Kazuhiro_Tsuchiya@gw.japan-highway.go.jp

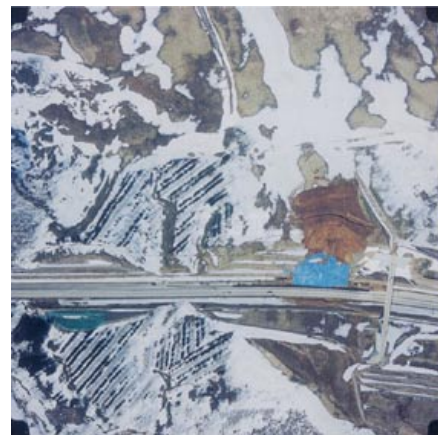
On April 13, 1999, a large-scale cut-slope failure occurred in the Kuromatsunai area in the Oshamanbe-Abuta section of the Hokkaido Expressway in the second snowmelt season after the expressway route opened (Figures 1, 2, and 3). The volume of the displaced material was approximately 7000 m³, which is unprecedentedly large for a slope failure due to snowmelt.

Figure 1 Kuromatsunai area and slope failure site (April 15, 1999)

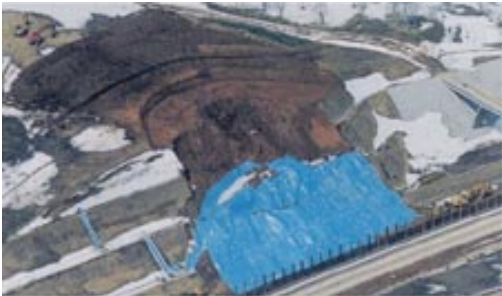
**Figure 2 Slope failure site
(Under construction)**

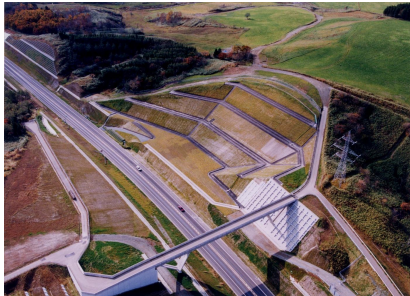
**Figure 3 Slope failure site
(After reconstruction)**

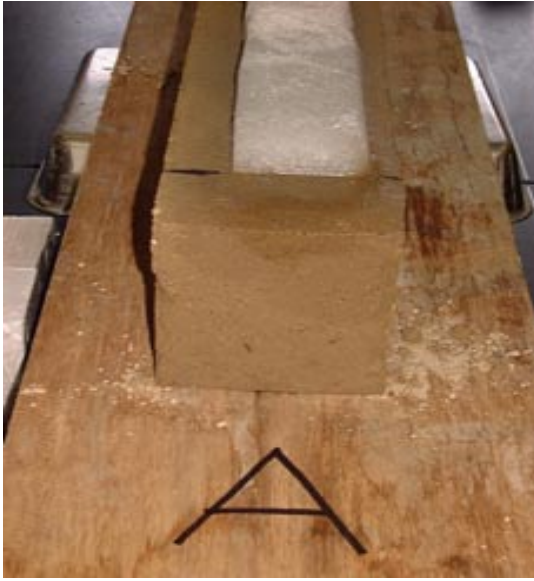
In the A test, meltwater flowing out of the lower end of the snow layer infiltrated into the test specimen, resulting in a failure two and a half hours later (Figures 11 and 12). The process leading up to the failure is shown in Table 1.

Figure 11 A test(10 minutes passed)

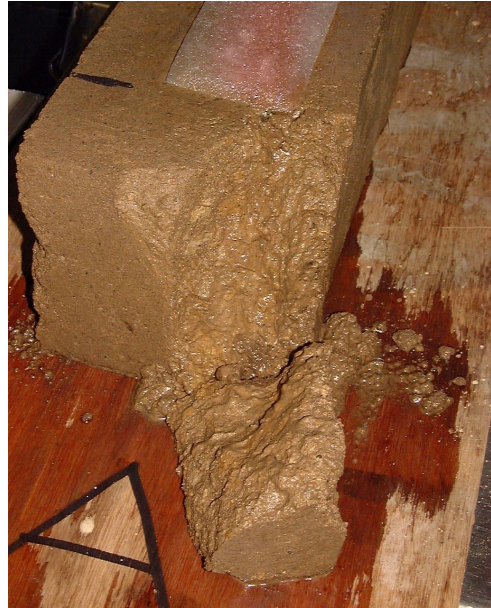
Figure 12 A test (2 hours 30 minutes passed)

Time	Description (Type A specimen)
10	Outflow begins
25	Side face heaving and local failure
50	Local failure of front face
80	Entire peripheral region (front region) saturated
2h25	Complete failure originating in side face failure region (near end of snow layer)

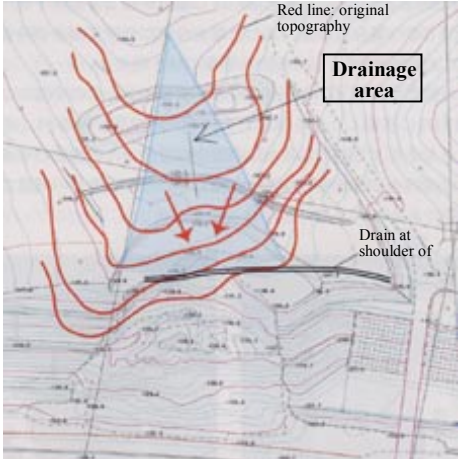
Figure 18 shows a projection onto a topographical map of contours before the slope failure. The area of the synclinal slope on the cut-slope side is about 1500 m², and, as shown, the topography of the slope failure site is conducive to concentration of rainwater and meltwater in the drainage area. The Figure 19 taken at the time of the slope failure shows that the scarp is close to the lower end of the snow layer.

before the slope failure. It may be concluded that a considerable amount of meltwater had run off, in a concentrated manner, to the lower end of the snow layer continuously and steadily until infiltration into the ground in the low-lying area near the shoulder of the slope resulted in the slope failure.

Figure 18 Slope failure site and drainage area

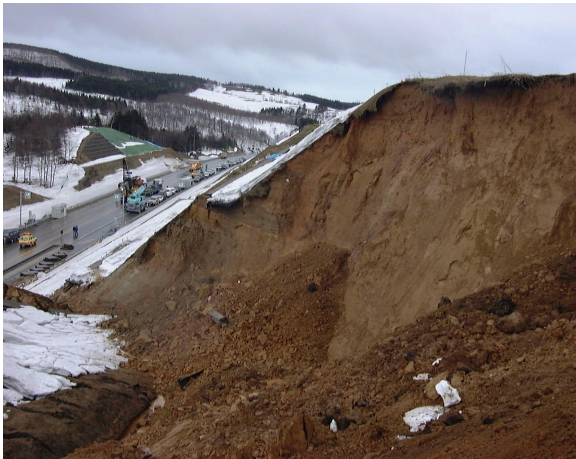
Figure 19 Slope failure site and drainage area

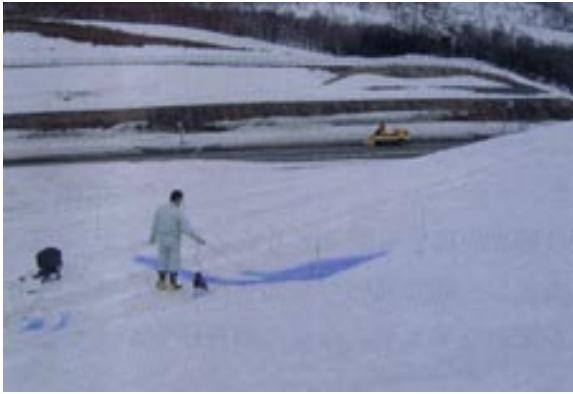
**Figure 21 Snow-covered slope
(April 4)**

Figure 20 shows daily meltwater measurements taken with a Lysimeter at the shoulder of the slope at the Kuromatsunai slope failure site. Figures 21 and 22 show the failure site on the 4th and 11th of April. The photographed areas are not exactly the same, but these photographs enable interpretation of changes over time in snow cover conditions. On April 4, the slope was still covered with a considerable amount of snow, but the slope was beginning to be exposed at places. Judging from meltwater measurements based on Lysimeter readings, the snowmelt process was still at the first half stage. By April 11, the melting zone had reached the shoulder of the slope, and the snow layer covering the slope began to disintegrate. On the south-facing slope, large patches of slope surface began to be exposed, and meltwater flow increased. Snow cover was still visible on the upper slope. Temperatures during this period were not particularly high.

From these findings, the time at which the highest part of the cut slope begins to be exposed may be thought of as the onset of snowmelt. Since the snowmelt rate increases sharply around this time as temperatures begin to rise, meltwater flows out in a concentrated manner from the lowest part of the upper slope to the shoulder of the cut slope. At this time slope inspection management in snowy regions needs to be planned and practiced according to the site conditions.

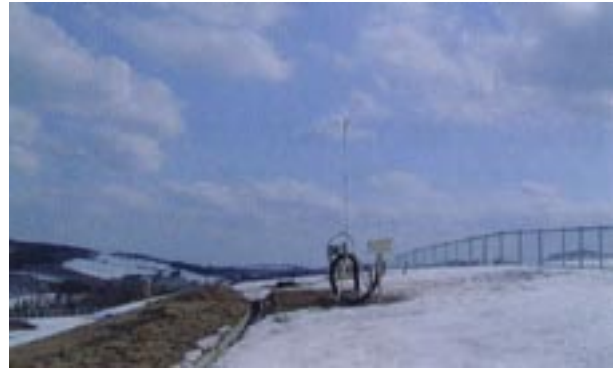
**Figure 22 Snow-covered slope
(April 11)**
