SODIUM CHLORIDE DIHYDRATE – A POTENTIAL CAUSE OF SLIPPERY ACCIDENTS

Morten Mejlholm*, Kaj Thomsen**, Peter Rasmussen**, Jørgen Vergod***, Freddy Knudsen****, Hugo Høyer*****

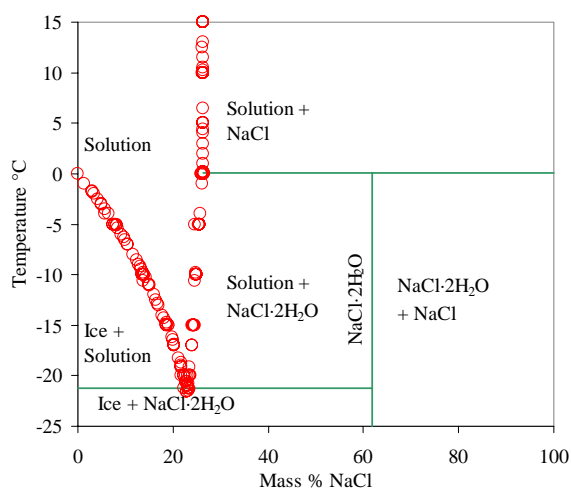
The phase diagram for the binary system $\text{NaCl}-\text{H}_2\text{O}$ is shown in Fig. 1. Each circle represents an experimentally determined temperature and composition at which a sodium chloride solution is in equilibrium with one or more solid phases. These experimental data were retrieved from the IVC-SEP Electrolyte Data Bank (2001). Three solid phases can exist

Figure 1: Phase diagram for the $\text{NaCl}-\text{H}_2\text{O}$ system. $\text{NaCl}\cdot 2\text{H}_2\text{O}$ is identical to hydrohalite (sodium chloride dihydrate)

in this system (ice, hydrohalite ($\text{NaCl}\cdot 2\text{H}_2\text{O}$), and anhydrous salt (NaCl)). At concentrations between 0 and 23.2 mass % NaCl , ice is the only solid phase that can be formed. At concentrations higher than 23.2 mass % NaCl either hydrohalite or anhydrous NaCl can form. Hydrohalite is stable at temperatures below 0.1°C and is the only form of sodium chloride that can be in equilibrium with a solution of NaCl at temperatures below 0.1°C . If the composition and the temperature of an aqueous NaCl solution is known, it is possible to determine from the phase diagram in Fig. 1 which phases are in equilibrium with each other.

The total salt concentrations in these four experiments correspond to 27, 36, 47 and 60 mass % salt. At these compositions we would expect to find saturated solutions in equilibrium with hydrohalite at -10°C (Fig. 1). Contrary to the expected, these surfaces were dry and the excess water was found in liquid inclusions. Although hydrohalite has a specific gravity of 1.61 and the saturated salt solution has a specific gravity of around 1.2 hydrohalite has a tendency to form a hard shell on the surface rather than precipitating like most other salts would.

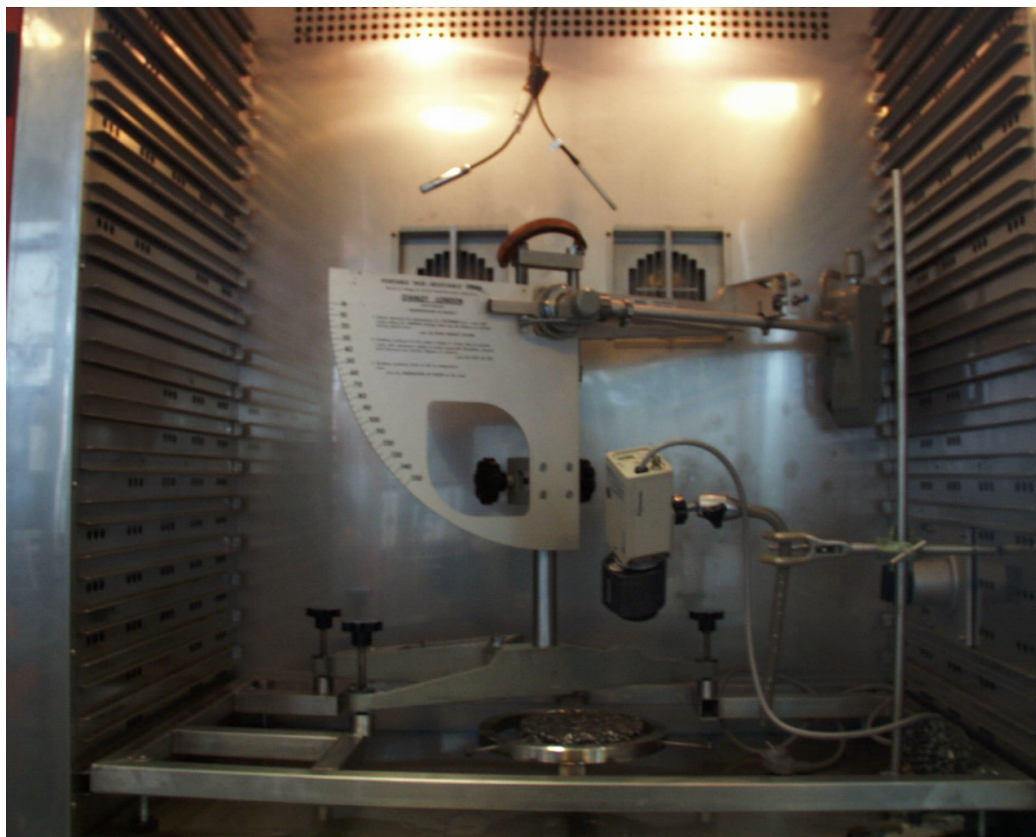
Normally the portable skid-resistance tester is used to measure the friction level at a single point

Figure 2: Experimental set-up for the friction measurements.

on the road. The apparatus measures the frictional resistance between a rubber slider (mounted on the end of a pendulum arm) and the road surface. In order to operate the apparatus in the laboratory modifications were made. Besides the metal frame for fixing and levelling the apparatus, a piston (released by compressed air) was installed on the apparatus in order to operate its release mechanism without opening the cooling chamber (and thereby disturb the temperature level). A window with a small hole (diameter 15 cm) covered with a movable piece of rubber, replaced the original window in the cooling chamber making it possible for the operator to catch the pendulum arm on the return swing.

The friction measurements were made with a portable skid-resistance tester according to a procedure based on the instructions given by the Road Research Laboratory (Road Note no. 27, 1960). The portable skid-resistance tester was rented from the Danish Road Directorates department in Roskilde. The results obtained by the portable skid-resistance tester are friction indices, and should not be taken as coefficients of friction. However, the friction index is a relative measure for the coefficient of friction. Fig. 2 shows a photo of the experimental set-up. The apparatus was fixed on a stainless steel frame and placed in a cooling chamber (WTI Binder model MK720, operated in constant temperature mode). The temperature level was -10°C . The frame was fixed on the chamber walls. The samples were set in a holder in the frame.

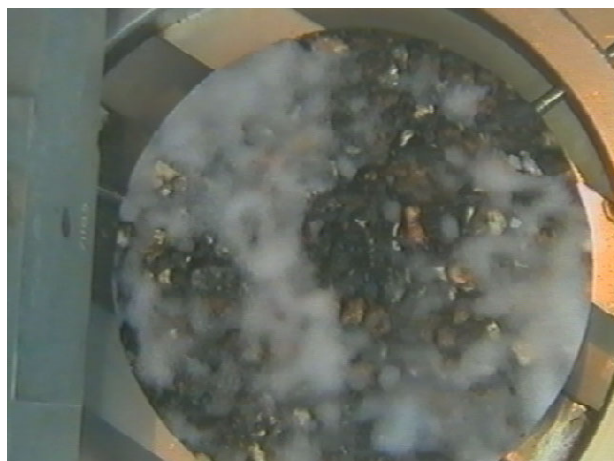
SMA+hydrohalite (c) was prepared by addition of saturated sodium chloride solution to the road sample partly covered with road salt. This system was stored at -10°C overnight (around 14 hours). The next day the road sample was covered with a hard, greyish surface consisting of minor islands of hydrohalite. Fig. 3 shows a photo of the sample denoted SMA+ hydrohalite (c). The friction index was measured to 45.4, and after one hour to 46.2. This friction index is comparable to that of SMA+Ice and can be categorized as potentially slippery.

**Figure 3: Sample denoted SMA+hydrohalite (c)**

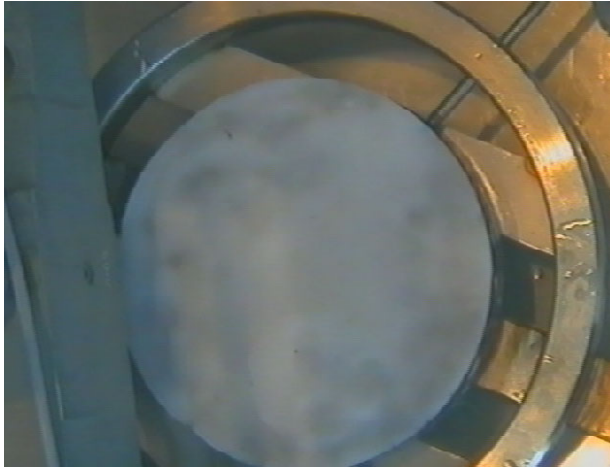
For the experiments SMA+hydrohalite (g-h-i), the pavement sample was covered by an unbroken layer of hydrohalite. The surface can be characterized as a thin, grey, hard layer (Fig. 4). The friction index is 67-68 which is significantly higher than the friction index of a similar pavement covered with islands of hydrohalite (45-50). From the measurements (g-h-i) we see again that the orientation of the pavement sample relative to the skid-resistance tester is of no importance.

Figure 4: Continuous surface layer of hydrohalite on pavement sample, SMA+Hydrohalite (g)

In the eight experiments (g-n) the surface on which the friction index measurement was performed consisted of an unbroken layer of hydrohalite. The average value of the friction index for these eight experiments is 65.8. A surface consisting of an unbroken layer of hydrohalite therefore can not be classified as slippery.
