# STUDY ON THE PREVENTION OF SNOW AND ICE ACCRETION ON ROAD STRUCTURES

Civil Engineering Research Institute of Hokkaido

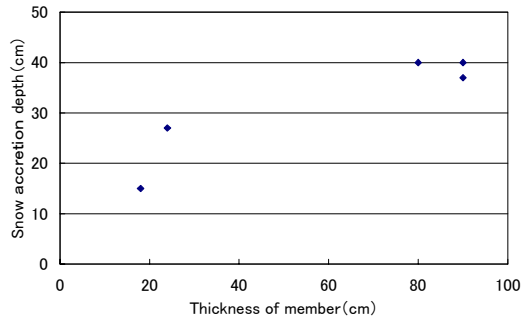
Figure 2 Relationship between Thickness of Members and Snow Accretion Depths

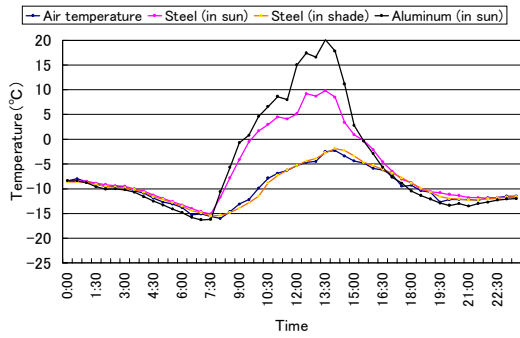
Figure 5 Hourly Change in Member Surface Temperature

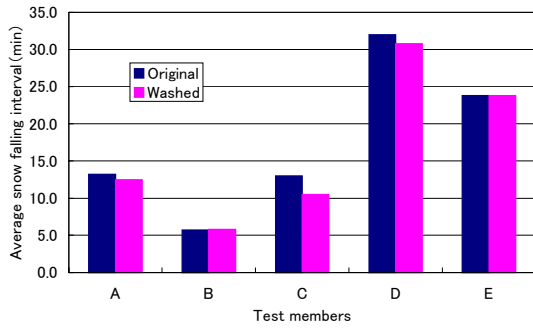
**Figure 8 Test Members and their Average Snow Falling Intervals**

Five sets of two steel bridge members each, with all members measuring 20 cm x 20 cm and each set having different surface treatments (physical properties) from the others, were set up outdoors. All of the members had been coated with alkyd resin, the paint commonly used on steel bridges. On the alkyd resin coating, the following treatments were made: Set A members were coated with a water-repellent agent; Set B members were coated with liquid wax; Set C members received no treatment; Set D members were roughened by unidirectional sandpapering; and Set E members were roughened by sandpapering in random directions. The outdoor experiments included filming of the members and measurements of wind velocity. Indoor measurements were also carried out of such surface properties as contact angle, surface roughness, coefficient of dynamic friction, and gloss. The indoor and outdoor data were then compared in order to find any relationship between the falling off of snow and surface properties. For each of the members, the average interval between snow fallings was obtained by averaging the time elapsed from the 1st falling to the 2nd falling and for the subsequent five intervals. Figure 8 shows the snow falling interval for each of the members. The "original" members had been in use for 12 months before the experiments, while the "washed" members had been washed with water prior to the experiments. The "washed" members tended to have shorter snow falling intervals than the "original" members. Figures 9 to 12 show the relationships between the various surface properties and the average snow falling intervals. The smaller the surface roughness ( $R_z$ ) and coefficient of dynamic friction, the shorter the snow falling interval. Also, the greater the gloss, the shorter the snow falling interval. There was little, if any, correlation between the contact angle and the snow falling interval. The "original" versus "washed" comparison revealed that washing helped recover the various surface properties, which indicates that cleaner and less degraded members may exhibit shorter snow falling intervals.

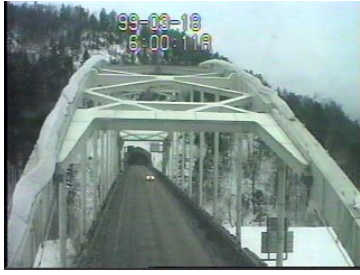
**Photograph 1 Snow Accretion**

Observation was carried out at the four bridges shown in Figure 1. Observation consisted of the recording of weather data, filming, and the observation of snow accretion. Following are the findings that were made. Snow and ice were seen to remain for an extended period on the Shikotsu and Fukusui bridges, while snow accretion and ablation were repeated on the Ryumon Bridge. As Figure 2 indicates, the thicker the member, the deeper the snow accretion tended to become. (The snow accretion depth in Figure 2 is the maximum depth observed.) A total of seven cases of snow falling were observed. In five of the seven cases, the temperature of the bridge at the time the snow fell was 0°C or over, having been heated by sunshine. Based on this, a bridge temperature of 0°C may be regarded as a threshold factor for snow falling. Figure 3 indicates that the bridge maintained a temperature ranging between -3 and +5°C relative to the air temperature. This may be considered to be the cause of the freezing, thawing, and subsequent falling of accreted snow. Figure 4 shows the relationship between the average wind velocity during the observation period and that at the time the snow fell from the member. It appears that no definite relationship can be deduced from the figure. One typical phenomenon observed was that snow accreted on arches would start creeping while simultaneously cracking laterally shortly before falling (ref. Photograph 1).

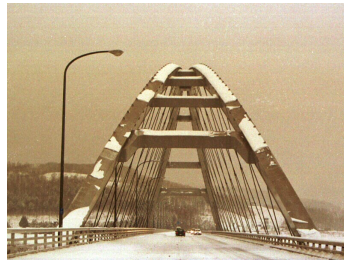
**Photograph 2 Toyokoro Bridge**

### (1) Toyokoro Ohashi Bridge (a Nielsen-Lohse bridge) on Route 38, Toyokoro (ref. Photograph 2)

Anti-accretion method: Painting (top surfaces of arches and struts were coated with highly water-repellent fluoro-resin paint.)
