CAUSE ANALYSIS OF SNOWMELT-INDUCED EXPRESSWAY SLOPE FAILURE THROUGH LABORATORY TESTING

Kazuhiro Tsuchiya

Maintenance Department, Hokkaido Branch,
Japan Highway Public Corporation
Tél.: +81-11-896-5211 / Fax: +81-11-896-5888
E-mail: Kazuhiro_Tsuchiya@gw.japan-highway.go.jp

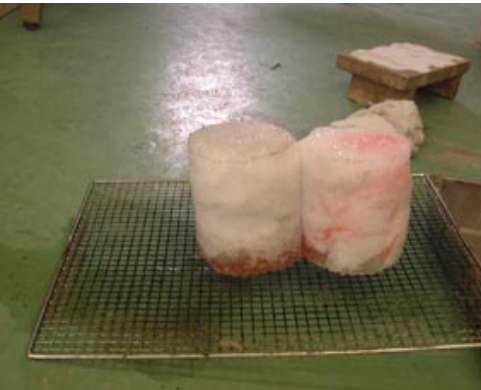
Small blocks were placed on wire netting and were observed as they melted under laboratory conditions. In the test, as long as the snow blocks were inclined, however slightly, meltwater seeped downslope through the snow blocks and dripped down from the lowest part of the snow without dripping down from intermediate parts of the snow blocks (Figure 4). Similar tests were conducted

**Figure 4 Meltwater dripping from
lowest point of snow block**

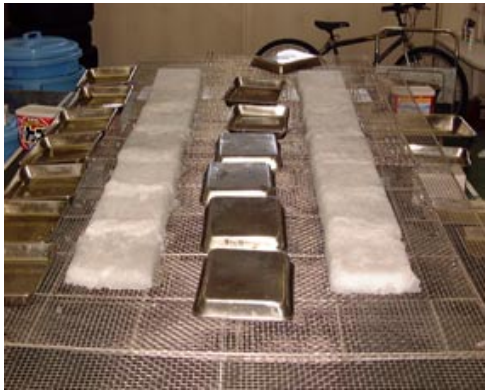
**Figure 5 Snow-on-wire-netting test
(before test)**

To test this hypothesis, a snow slope on wire netting was prepared in the laboratory. The melting process was observed and meltwater runoff was measured. The snow slope was about 1.6 m long, and its gradient was about 8%. A continuous snow layer was formed by placing snow blocks on the wire netting. Blocks of granular snow measuring 3 cm in depth, 18 cm in width and 23 cm in length were used (Figure 5). In the experiment, the following were observed:

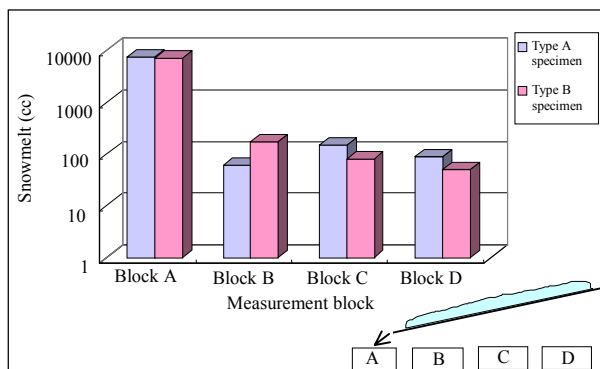
- Snowmelt runoff at the lower end of the slope was close to 100% of the total amount of meltwater (Figure 6).
- After 50 cc of water was sprinkled over the snow, meltwater runoff at the lowest part of the snow layer increased temporarily, but there was no vertical flow of water from intermediate parts of the snow layer. The time consumed for snow to melt showed no significant differences (Figure 7).
- It was only when the snow layer became thin and continuity of the snow blocks was lost that meltwater dripped down from parts of the snow layer other than the lower end.

Figure 6 Snowmelt runoff by block

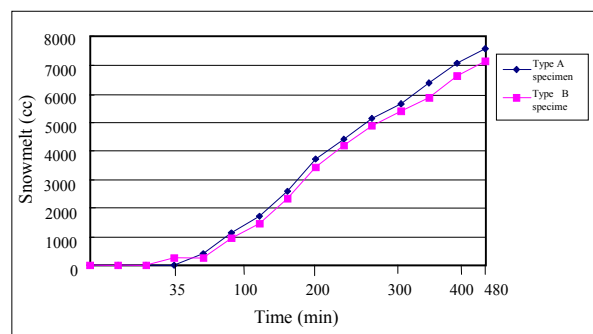
Figure 7 Changes over time in snowmelt runoff at lower end

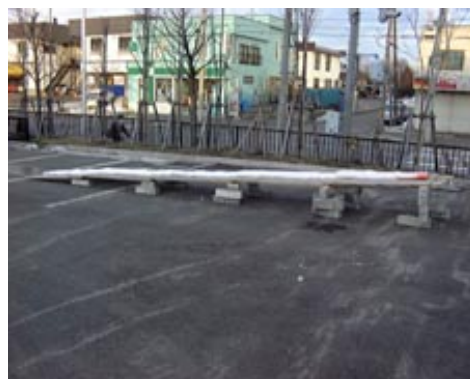
In the test, in the evening or morning hours when temperatures were low, meltwater seeped through the near-bottom region in the snow layer and flowed out from the lower end of the layer (Figure 8). However, as temperatures rose and solar radiation increased in the daytime, the snow became slushy. As a result, snow began to dangle through wire net openings as the snow melted, and meltwater began to drip down from several locations (ambient temperature: 5-6°C).

Figure 8 Outdoor experiment

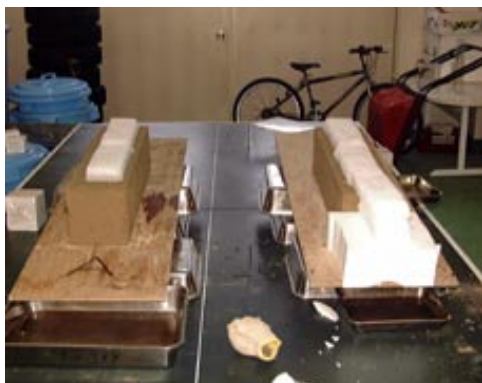
-A test: The test specimen was covered with snow so that meltwater drips directly onto the test specimen (Figure 9; hereafter in this paper called "A test").

In the A test, meltwater flowing out of the lower end of the snow layer infiltrated into the test specimen, resulting in a failure two and a half hours later (Figures 11 and 12). The process leading up to the failure is shown in Table 1.

Figure 9 Snowmelt test using soil specimen (left: A test, right: B test)

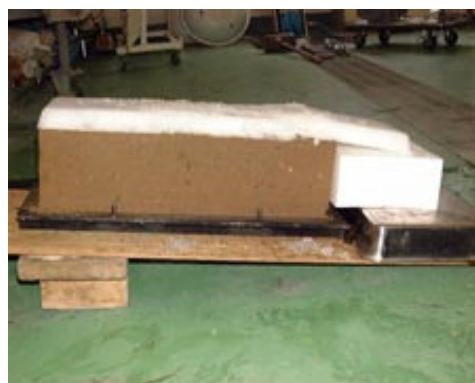
-B test: The top and front face of the test specimen were covered with snow (Figure 10; "B test").

Figure 10 B test (end of snow layer outside test specimen)

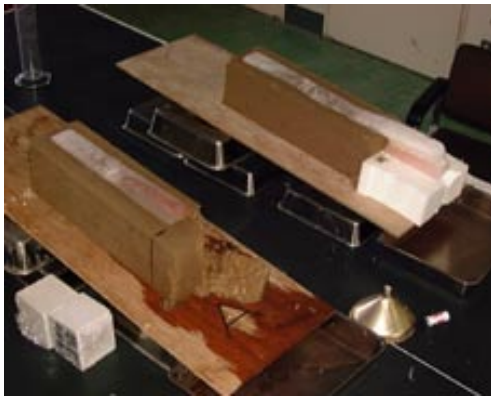
Figure 13 Drainage of meltwater

In the B test, meltwater flowed out from the front-end part of the snow layer, and the test specimen was in a sound condition even after the snowmelt process ended (Figures 13 and 14). Measurement of the weights of the test specimens showed that the amount of infiltration into the test specimen was 40 cc, which is about 3% of the total volume of meltwater (Table 2). In the cases where red ink was introduced from the upper end of the snow-block layer, meltwater was observed to flow downslope along the bottom of the snow layer and flow out from its lower end. After the snow on the test specimen in the B test disappeared, a snow layer twice as thick as the first snow layer was placed on the test specimen, and the snowmelt test was continued. In this test, the test specimen remained in a

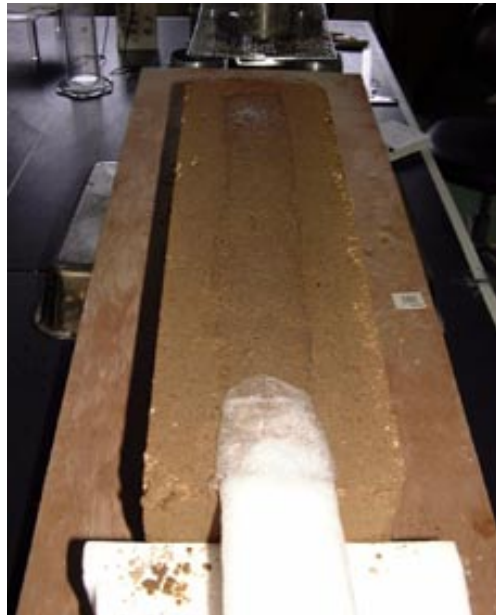
Figure 14 B test (3 hours 30 minutes passed)

sound condition, and heaving of side faces did not occur. The weights of the test specimens did not change, indicating that infiltration into the test specimens did not occur even when the volume of snow was doubled.

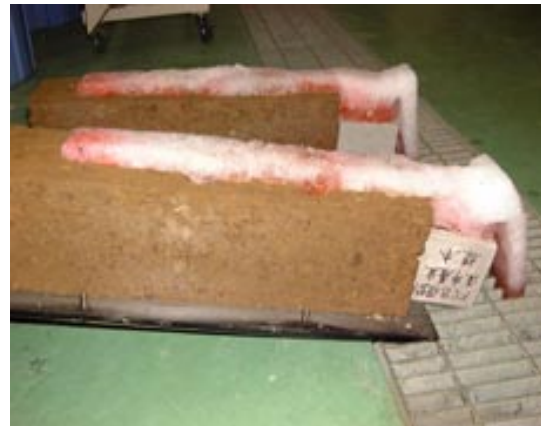
The times consumed for snow to melt showed slight differences, but the slope angle did not affect drainage; almost all meltwater flowed out of the test specimen after moving through the snow layer (Figure 15). Low permeability of the cohesive soil is thought to have affected the test results.

Figure 15 B test with different slope angles (foreground: 10 deg., background: 5 deg.)

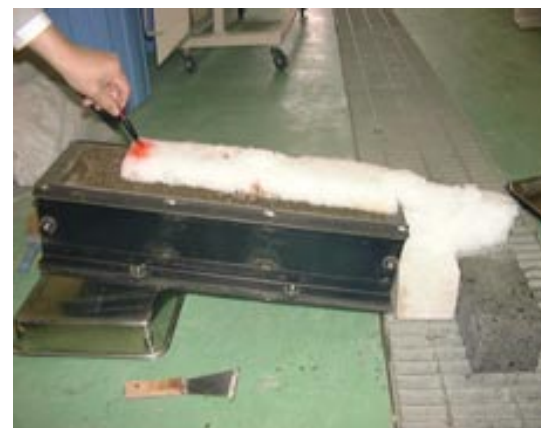
A concrete form was filled with sand, and the slope angle was set to 10 degrees. Then B test was conducted (Figure 16). In this snow-on-sand test, almost all meltwater was absorbed in the sand, and drainage through the snow layer was not observed. In the next test in which the slope angle was increased to 30 degrees, no water flowed out through the snow layer even after a considerable amount of water was sprinkled over the snow layer.

Figure 16 Snowmelt test on sand

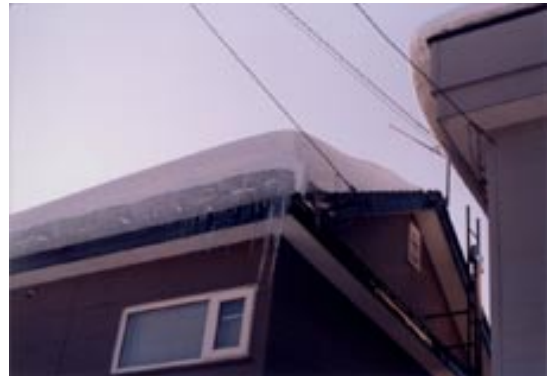
From the way rooftop snow melts in the real world, I have a hypothesis concerning the phenomenon of meltwater or rainwater flowing through a snow layer. In Figure 17, the lower end of the snow layer is frozen. I hypothesize that as meltwater seeps downslope through the snow layer and is refrozen at the lower end of the snow layer, the ice formed along the lower end of the snow

Figure 17 Melting rooftop snow

layer becomes thicker over time. Am I wrong in assuming that if meltwater drips down from the snow layer before reaching its lower end, the phenomena mentioned above will not occur and the rooftop snow will fall to the ground sooner because meltwater will flow downslope on the rooftop surface.

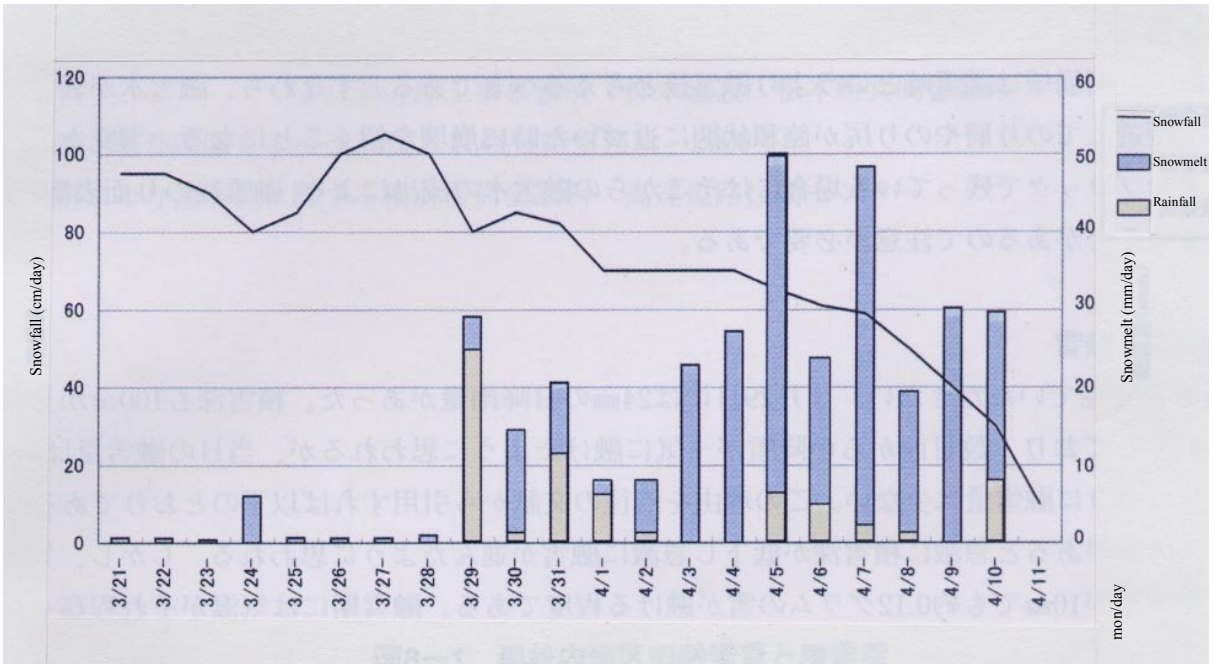
Figure 20 Snowmelt and snowfall in Kuromatsunai area

Figure 20 shows daily meltwater measurements taken with a Lysimeter at the shoulder of the slope at the Kuromatsunai slope failure site. Figures 21 and 22 show the failure site on the 4th and 11th of April. The photographed areas are not exactly the same, but these photographs enable interpretation of changes over time in snow cover conditions. On April 4, the slope was still covered with a considerable amount of snow, but the slope was beginning to be exposed at places. Judging from meltwater measurements based on Lysimeter readings, the snowmelt process was still at the first half stage. By April 11, the melting zone had reached the shoulder of the slope, and the snow layer covering the slope began to disintegrate. On the south-facing slope, large patches of slope surface began to be exposed, and meltwater flow increased. Snow cover was still visible on the upper slope. Temperatures during this period were not particularly high.

From these findings, the time at which the highest part of the cut slope begins to be exposed may be thought of as the onset of snowmelt. Since the snowmelt rate increases sharply around this time as temperatures begin to rise, meltwater flows out in a concentrated manner from the lowest part of the upper slope to the shoulder of the cut slope. At this time slope inspection management in snowy regions needs to be planned and practiced according to the site conditions.
